**Mejoramiento estructural de la vivienda tradicional de
adobe de Chiapa de Corzo, Chiapas**

*Structural improvement of the traditional housing of adobe from Chiapa de
Corzo, Chiapas*

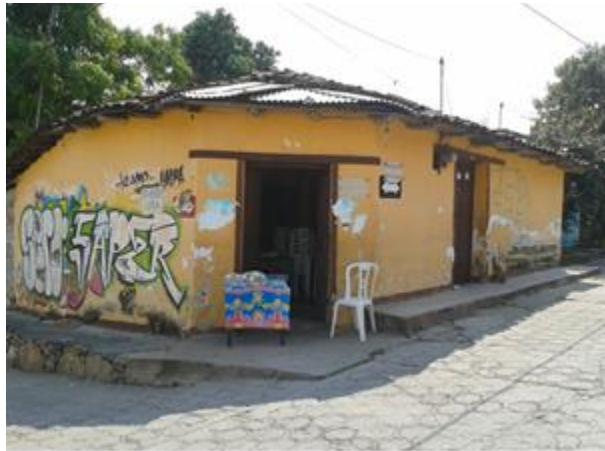
Housing V1, according to its owner, Evangelina Montero Aguilar, is over 80 years old and is located on Miguel Hidalgo Avenue, corner of Tomás Cuesta Street. It was built on the basis of cyclopean-type masonry foundation, made with ball stone and sand-lime mortar, walls of adobe 40 cm thick and roof structure with round beams and wooden slats to support the roof of mud tile. In general, the house had several fissures at the intersection of the walls and at the foot of the doors, in addition to the absence of mud tiles on the roof of the main entrance (figure 4).

Figura 4. Vivienda tradicional V1 de Chiapa de Corzo, Chiapas

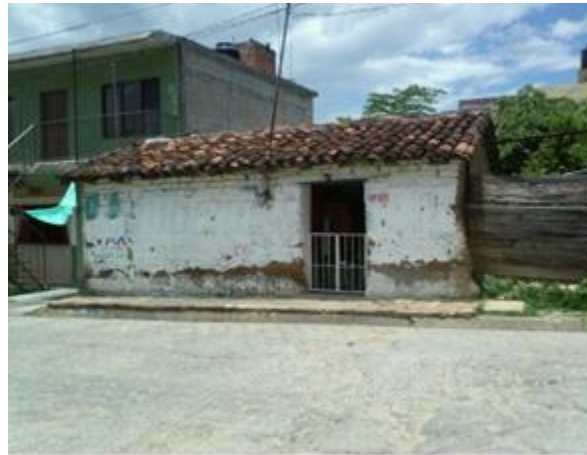
Housing V2 is located on Tomas Cuesta street, No. 80, between Alvaro Obregon and Miguel Hidalgo avenues, in the San Vicente neighborhood. According to its owner, Reyneria Moreno Cuesta, it was built by his father more than 70 years ago. It has constructive characteristics similar to the previous one, except for the thickness of the walls, which vary from 38 cm in the main facade to 30 cm in the rear facade. In addition, it is not covered with mortar, since it only has a thin layer of lime on the main facade that has served to protect the adobe from the outside environment. There are also fissures and severe structural problems in a head wall that is slightly collapsed; also, the wooden structure of the roof is in very bad condition (figure 5) (Escamirosa *et al.*, 2013).

Figura 5. Vivienda tradicional V2 de Chiapa de Corzo, Chiapas

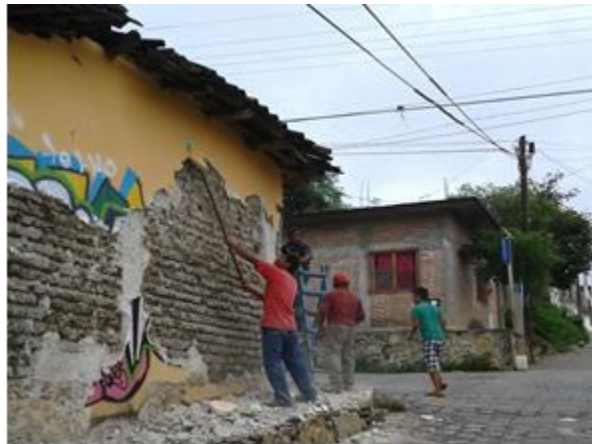
Figura 6. Retiro de recubrimiento en la vivienda V1

The previous works to the structural reinforcement consisted in extracting the doors and the mortar of both sides of the walls in the house V1 (figure 6); in the case of housing V2, the lime layer was removed. These tasks were carried out carefully to avoid major damage to the adobe.

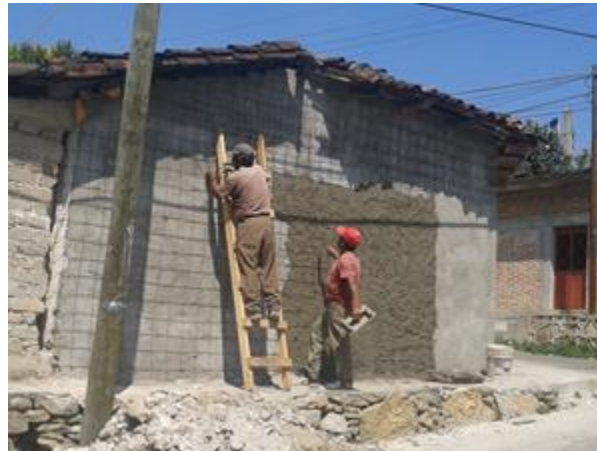
Figura 7. Aplicación de las capas de mortero

Next, the walls of house V1 were covered with a layer of cement-sand mortar, ratio 1 to 3 (average compressive strength of 227 kg / cm²), hand-launched, leveled and with a minimum thickness of 1 cm . Subsequently, the steel mesh (6x6 / 10x10, 6 "x6" grid with 10-gauge steel wires in both directions) was placed, with 60cm overlaps in the sections that were fastened to the walls from the following procedure based on the Complementary Technical Standards (NTC) (2004): a 30 cm grid was drawn on the walls, and at each intersection point drilling was done with a 5/16 "diameter drill bit; Through the hole, a wire was passed to hold

the steel mesh on both sides of the wall. Then, a second layer of mortar was applied, just like the previous one, and a thin layer of cement-calhydrate, ratio 1:10, was placed to obtain the final finish on the walls, similar to the original caulking of the adobe houses. (figure 7). The works concluded with the application of the painting (figure 8) (Escamirosa *et al.*, 2014).

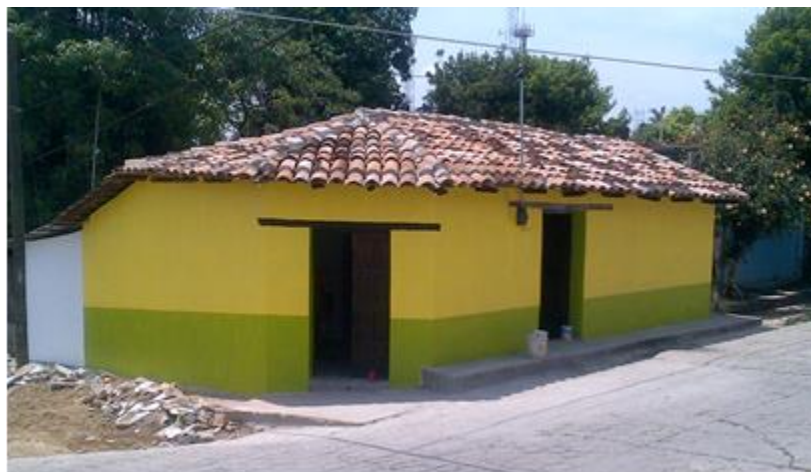
Figura 8. Vivienda tradicional V1 rehabilitada

In both houses were replaced the pieces of wood and damaged tiles of the roof; also, 30x30 cm ceramic tile was placed on the floors and, finally, the doors were installed and paint was applied on all the elements trying to preserve the typology of the traditional houses of Chiapa de Corzo (figures 8 and 11) (Escamirosa *et al.*, 2014).

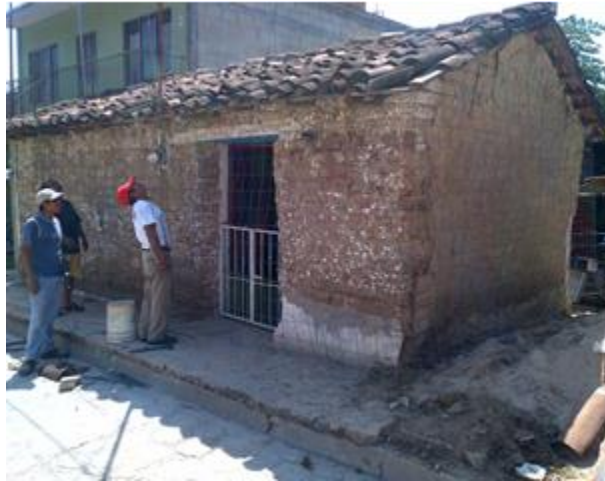
Figura 9. Fijación del refuerzo en vivienda V2

In house V2, unlike the previous one, the steel mesh was placed directly on the walls, without a previous layer of mortar (figure 9). Once the mesh was secured, the first layer of cement-sand mortar was applied with a minimum thickness of 1 cm, and after sufficient time of mortar setting (2 hours), the second layer was placed (figure 10).

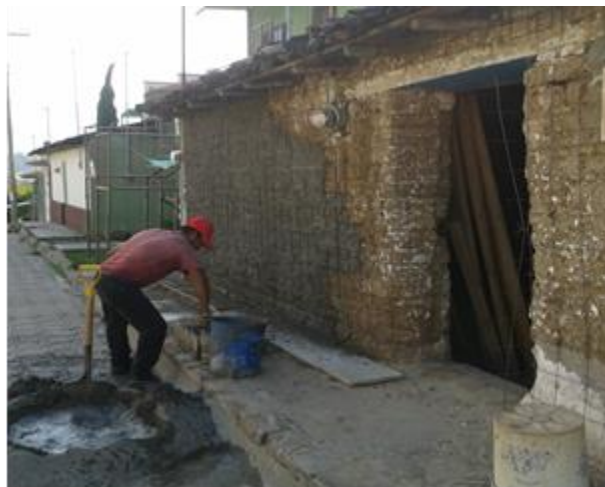
Figura 10. Aplicación de la capa de mortero

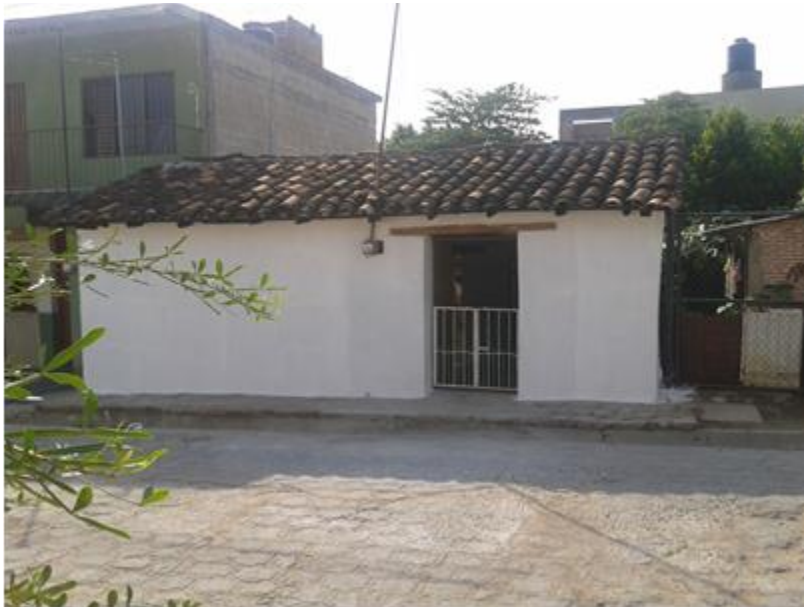
Figura 11. Vivienda tradicional V2 rehabilitada

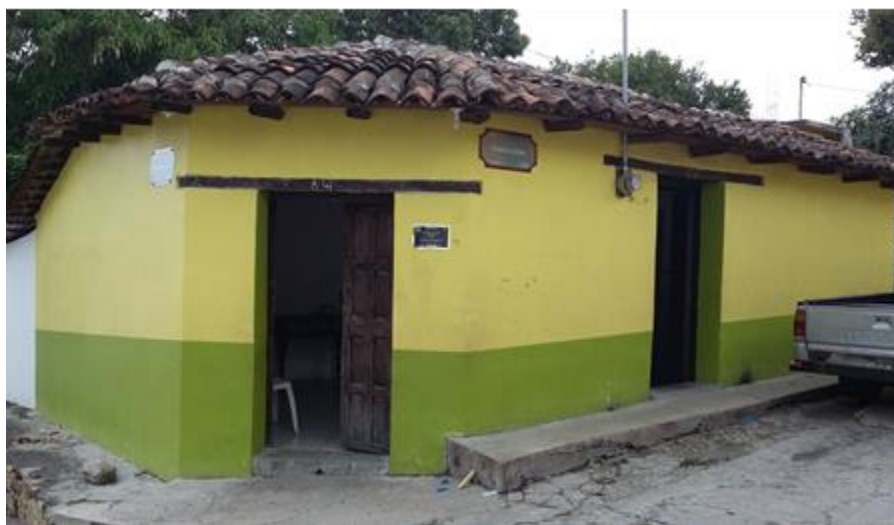
Figures 20 and 21 correspond to the images obtained from houses V1 and V2 one day after the earthquake occurred on September 7, 2017 in the state of Chiapas, which had a magnitude of 8.2 on the Richter scale. In the visual inspections carried out in both houses on September 8, 2017, it was observed that the reinforced adobe walls with flattened and electrowelded

mesh did not show any damage, which shows that the behavior after the seismic loads occurred was satisfactory.

Figura 20. Imagen de la vivienda V1 obtenida el 8 de septiembre de 2017 a las 18:20 horas

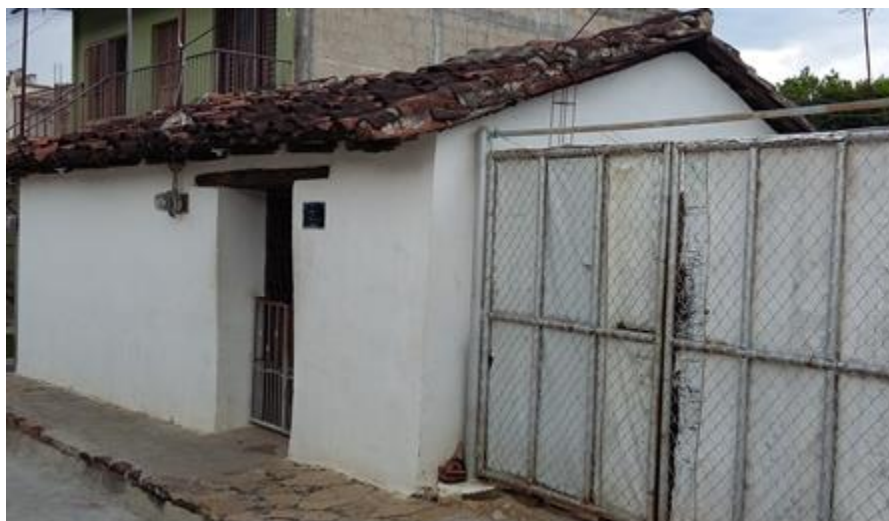
Figura 21. Imagen de la vivienda V2 obtenida el 8 de septiembre de 2017 a las 18:25 horas
