**Mejoramiento estructural de la vivienda tradicional de
adobe de Chiapa de Corzo, Chiapas**

*Structural improvement of the traditional housing of adobe from Chiapa de
Corzo, Chiapas*

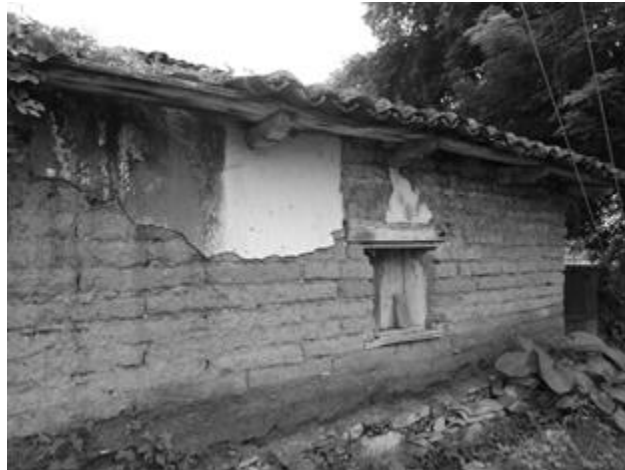
Figura 2. Vivienda tradicional con muros de adobe en Chiapa de Corzo, Chiapas

As seen in figure 2, the adobe of the walls of traditional dwellings is made up of prismatic pieces formed in wooden molds and dried only in the sun, which makes them vulnerable to seismic action. Even so, this material has been used historically in homes that have passed from generation to generation without any type of professional supervision (Flores, Pacheco and Reyes, 2001).

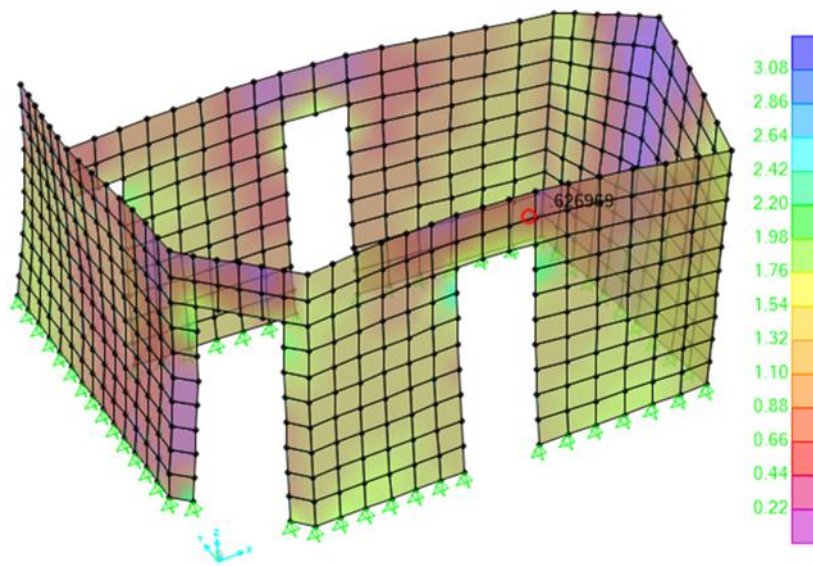
Figura 23. Distribución de esfuerzos cortantes (combinación gravitacional + 100 % sismo transversal + 30 % sismo longitudinal)

In the case of diagonal tension stresses, the results indicated in table 4 and figure 23 confirm that even when the reinforcement provided by the mesh flattens produces an increase in the shear stresses in the adobe, mainly in the corners of openings of doors, this is not counterproductive, since the efforts are absorbed by the mesh, which limits the damage in the flat and, mostly, in the adobe. In this way, the model allowed establishing that the mesh has an important role of protective structural jackets that not only provides rigidity to the system, but above all ductility.
